Suction Pump-VacPro Quick Service Guide

REV – 1.1

APEX Medical Corp.

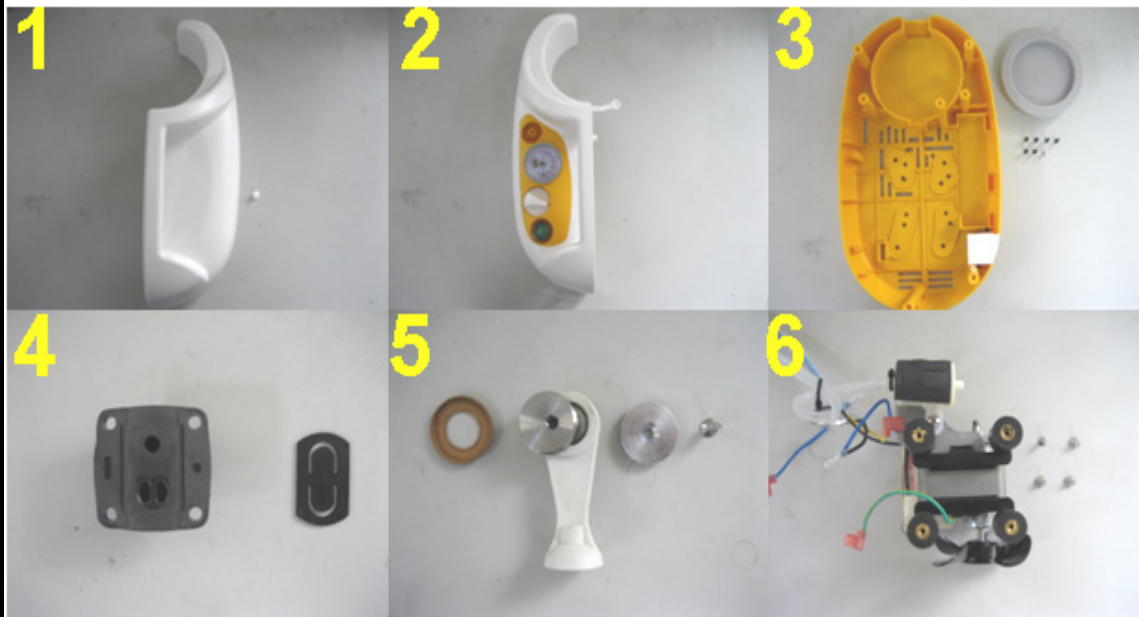
Explosion Lineup :

No.	Part Description
1	Rear cover with tampon x 1
2	Front cover subassembly, includes: ● Control panel x 1 ● Vacuum Gauge x 1 ● Pressure Regulator Knob x 1 ● Power switch x 1 ● Power switch cover x 1
3	Bottom subassembly, includes: ● Coaster x 1 ● Screw x 8 ● Electrical outlet x 1
4	Cylinder head subassembly, includes : ● Cylinder head x 1 ● Valve plate x 2 ● Screw x 4
5	Connecting rod subassembly, includes : ● Connecting rod x 1 ● Compressing ring x 1 ● Counterweight x 1 ● Set screw x 1
6	● Motor subassembly x 1

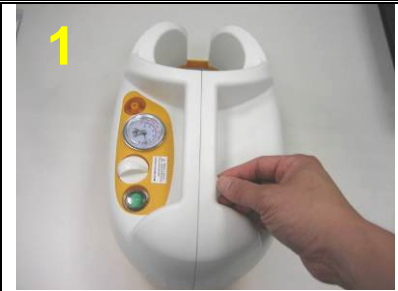
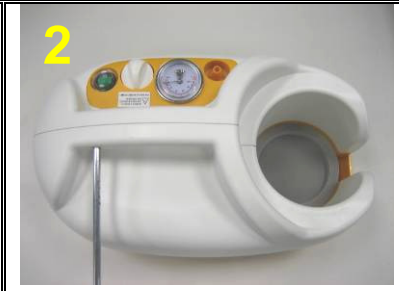
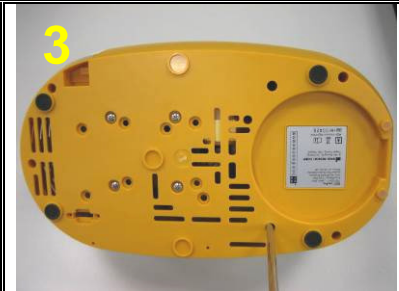
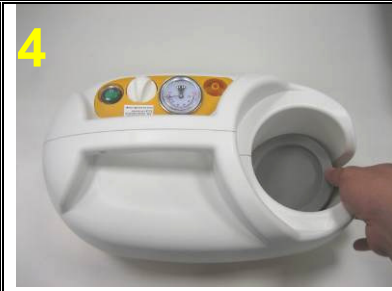
<p>Remove the tampon from rear cover.</p>	<p>Loose the screw which secured the covers.</p>	<p>Loose 7 screws from the bottom.</p>	<p>Remove the coaster.</p>

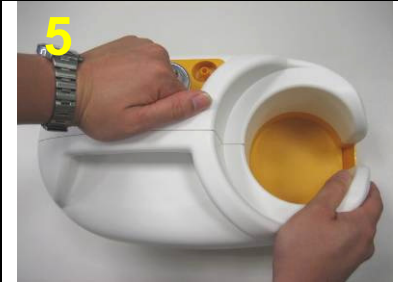
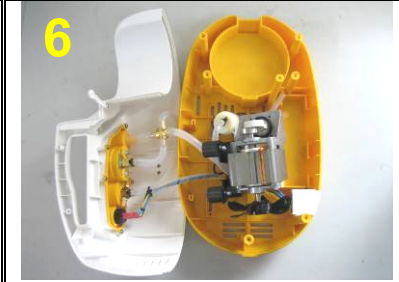
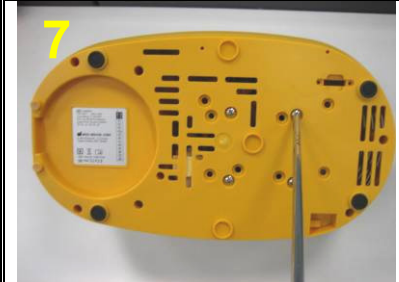
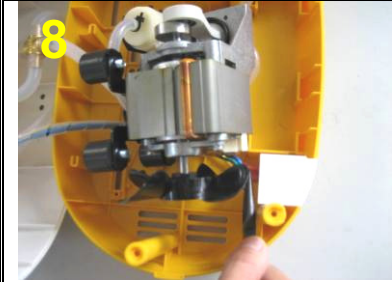
<p>Apart the rear cover, with one hand secures the other.</p>	<p>Disconnect the tubing and wire cables, and removed the front cover.</p>	<p>Loose 4 lock screws from the bottom which connect to Motor.</p>	<p>Disconnect the terminal between motor and outlet.</p>

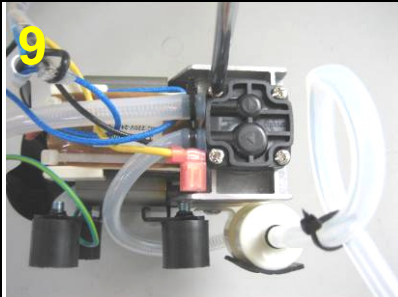
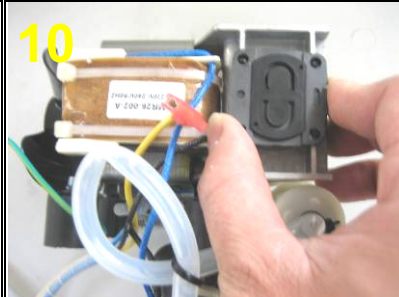
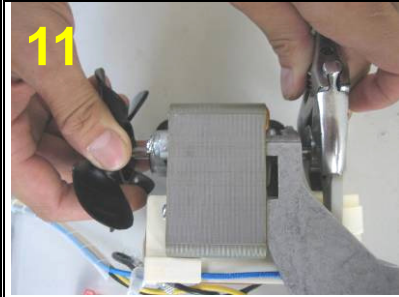
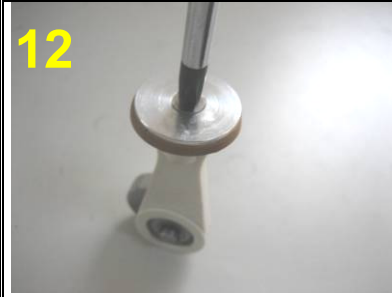
<p>Loose 4 lock screws, and remove cylinder head.</p>	<p>Remove cylinder and valve plate.</p>	<p>Hold the counter weight with a spanner. Turn the cooling fan with the other hand, Connecting rod can be removed.</p>	<p>Loose the lock screw, remove the compressing ring and the counter weight.</p>

* Assembly procedure should be carried out in the exact reverse sequence as the disassembly.

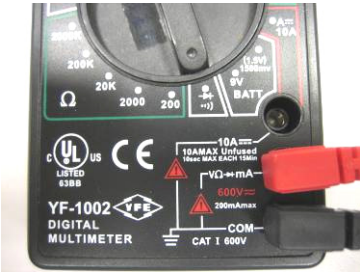
[Fig A3.1-1]

Multimeter mode setting.

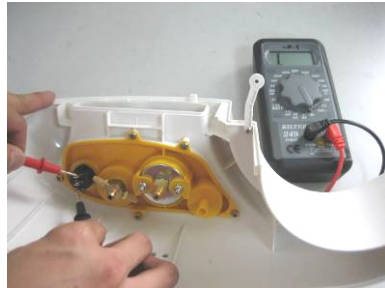
[Fig A3.1-2]

3.1 Use a Multimeter to gauge the conductivity between 2 switch pins should be good, refer to below figures and criteria.

Conductive if switch on.

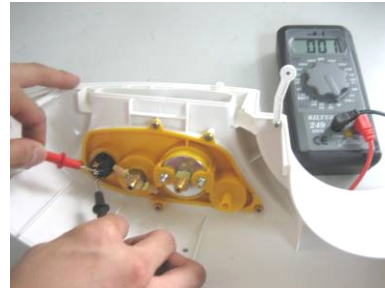
[Fig A3.1-3]

Disconnect if switch off.

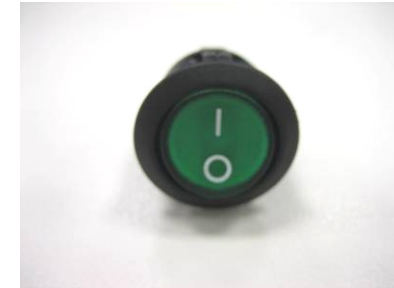
[Fig A3.1-4]

Power switch

3.1.1 If the abnormal conductivity between 2 switch pins, replace with a new power switch, and re-start up the device again.

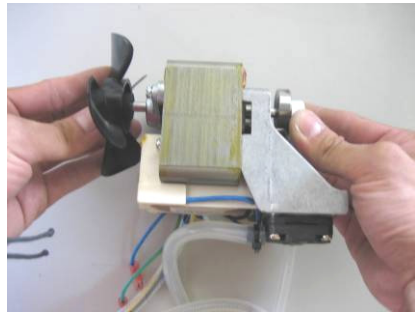
[Fig A4.1] Vertical movement up and down.

4.1 Remove the cylinder block and turning the cooling fan, The connecting rod should have the vertical movement up and down; refer to Fig A4.1~A4-2 for detail..

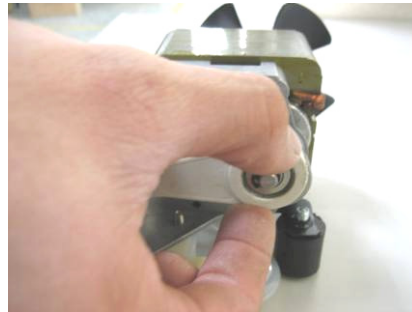
[Fig A4.2] Rotate the connecting rod.

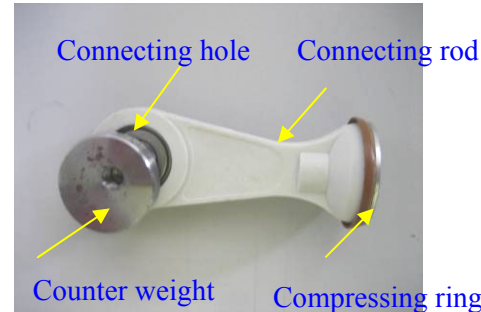
[Fig A4.3] Front view of connecting rod.

4.2 Also, check if any irregular defects happened to connecting rod; such as break-apart, damage, rusty, scratch...etc; refer to Fig A4.3~A4-4 for detail.

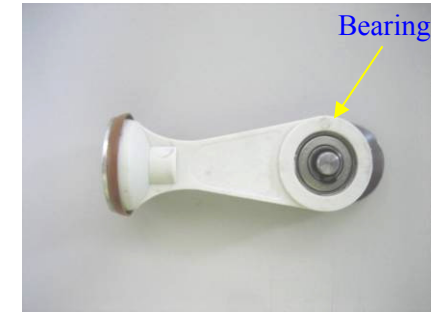
[Fig A4.4] Rear view of connecting rod.

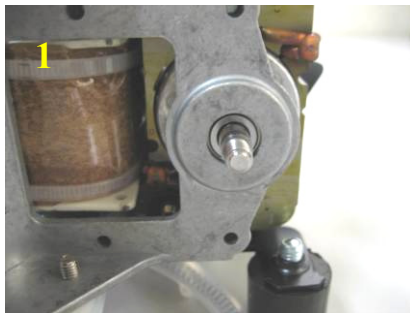
The flat cut on pump shaft is for fix the counter weight screw.

[Tip] 3 steps to fix the Connecting rod to the Pump Shaft securely :

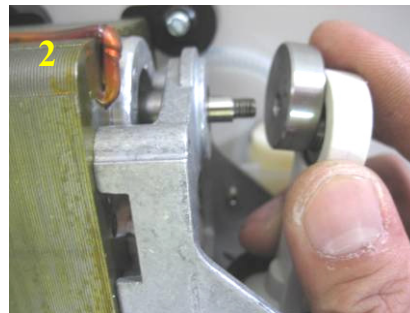
Keep the counter weight screw horizontal. Turn the flat cut to face the air hole. Fix the piston set to the pump shaft.

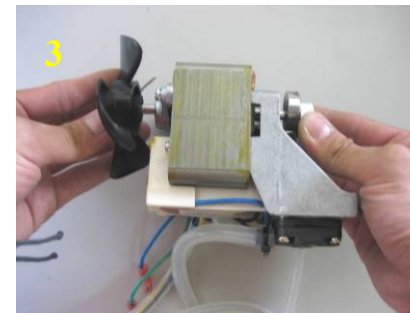
Connecting rod work checking to see normal working after secured.

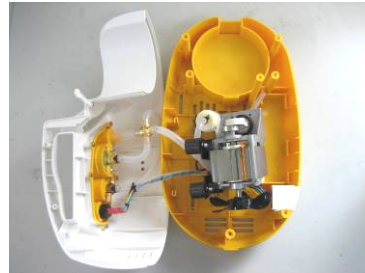
[Fig B2.1] Tubing inside motor and battery

- 2.1 Check all silicone tubing for broken or obstruction.
Refer to Fig B2.1 for detail.

- 2.1.1 If any, replace new silicone tubing and try again.

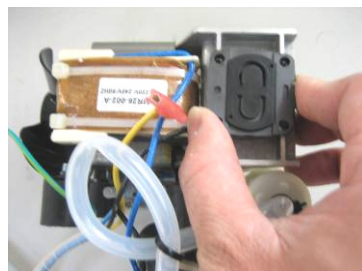
[Fig B3.1] Cylinder

- 3.1 Remove the cylinder head, and check if the valve plate
Refer to Fig B3.1~B3.2 for detail.

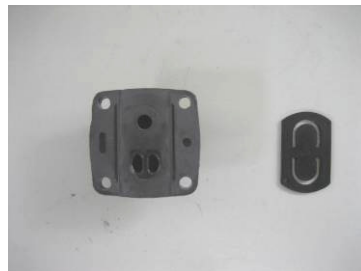
[Fig B3.2] Cylinder & valve plate

- 3.1.1 If anything irregular found, replace with a new diaphragm and try again.

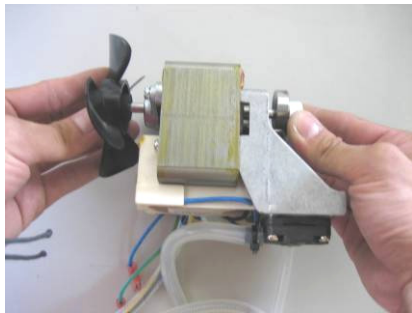
[Fig C1.1] Vertical movement up and down.

1.1 Remove the cylinder block and turning the cooling fan, The connecting rod should have the vertical movement up and down; refer to Fig C1.1~1-2 for detail.

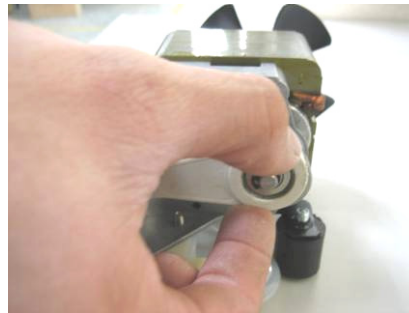
[FigC1.2] Rotate the connecting rod.

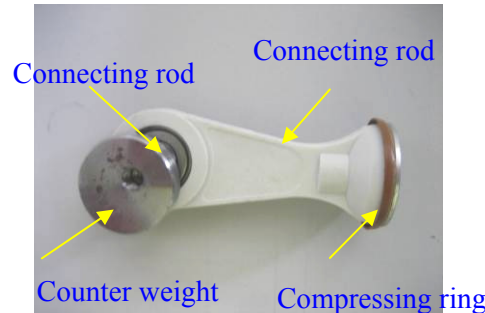
[Fig C1.3] Front view of connecting rod.

1.2 Also, check if any irregular defects happened to connecting rod; such as break-apart, damage, rusty, scratch etc; refer to Fig C1.3~1.4 for detail.

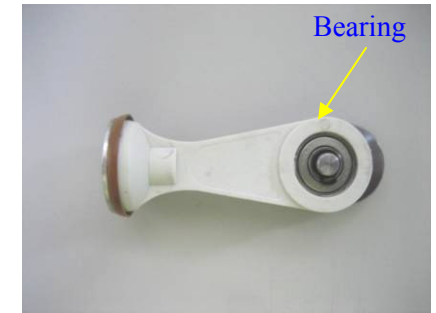
[Fig C1.4] Rear view of connecting rod.

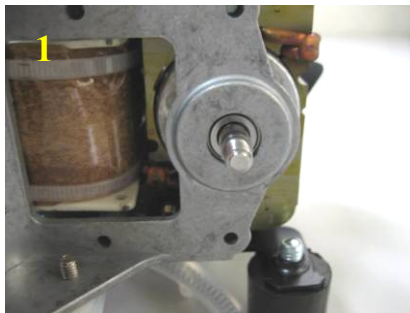
The flat cut on pump shaft is for fix the counter weight screw.

[Tip] 3 steps to fix the Connecting rod to the Pump Shaft securely :

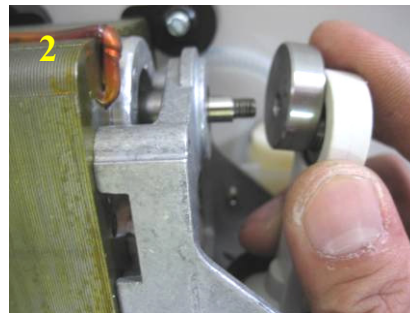
Keep the counter weight screw horizontal. Turn the flat cut to face the air hole. Fix the piston set to the pump shaft.

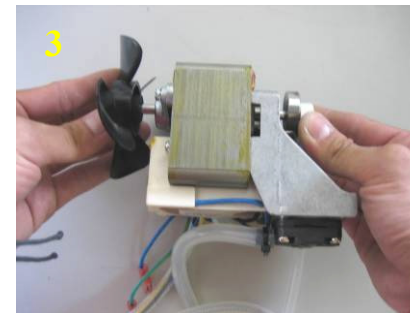
Connecting rod work checking to see normal working after secured.
